THINGS TO KNOW ABOUT CARPENTER BEES

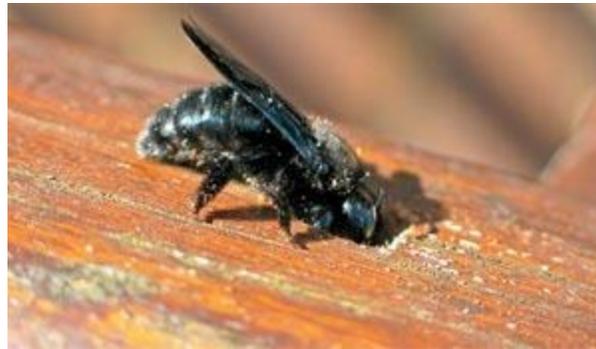
Although carpenter bees prefer hardwoods such as cedar, redwood, or cypress, they happily attack pine and most other species of wood. Even pressure treated wood is not immune from carpenter bee attack. As the bee drills into the wood, coarse sawdust may be seen coming out of the hole and piling up beneath the hole. Since it only takes a couple of hours for a carpenter bee to drill a hole a few inches deep, lots of holes can appear over a fairly short period of time.

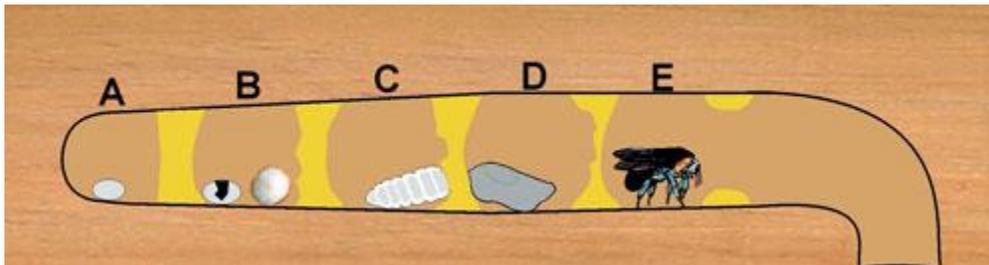
If we take a look at a cross section diagram of a carpenter bee gallery we can see how. After drilling out a four to five inch long gallery, the female carpenter bee lays an egg in back of the gallery then places a plug of pollen she has gathered to form a chamber (A). She continues doing this until there are four to six egg chambers in place. After a few days the egg hatches and a small white grub emerges (B). The grub feeds on the pollen plug for a few weeks (C) until it is ready to pupate (D) and change into an adult bee (E). If you look at the way the gallery is constructed you can see why spraying a pesticide in the hole may not kill all of the developing bee larvae. The pollen plugs prevent the pesticide from getting to the rear chambers. So before you spray any pesticide into a carpenter bee hole be sure to run a stiff wire all the way to the back of the gallery to break through any pollen plugs. That way all of the larval chambers will be exposed to the pesticide.

If you find carpenter bee holes in late spring or early summer it's difficult to tell if there are bee larvae developing in the tunnels. The best thing to do is to run a length of flexible wire into the tunnels in order to break through the pollen plugs separating the chambers. Then spray a pesticide into the hole and seal it up. The same thing should be done on holes found in the fall or winter to kill any bees that may be over-wintering in the holes. Just remember to plug the holes since they will attract more carpenter bees come spring.

Several people told us that although they sprayed a pesticide into the holes, carpenter bees later emerged, in some cases even after the holes were plugged. How can this happen?
